Manhole Inspection Summary

Manhole # S43K__021MH

Insp Date: **12/18/08 11:22 AM**

Location Address: **1610 alicenna st**

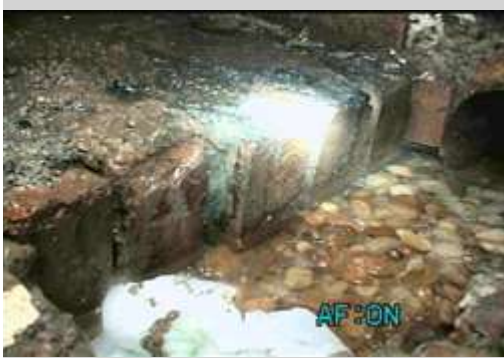
Defect 2

Condition: ☐ Sound ☐ Cracked ☐ Root Intrusion ☐ Deteriorated ☐ Leaks ☒ **Debris**

channel debris

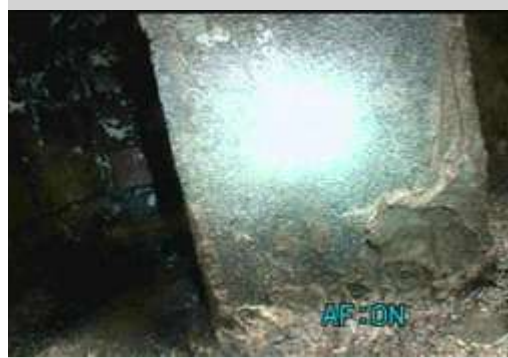
Defect 1

Condition: ☐ Sound ☐ Cracked ☐ Root Intrusion ☐ Deteriorated ☐ Leaks ☒ **Debris**

bench debris

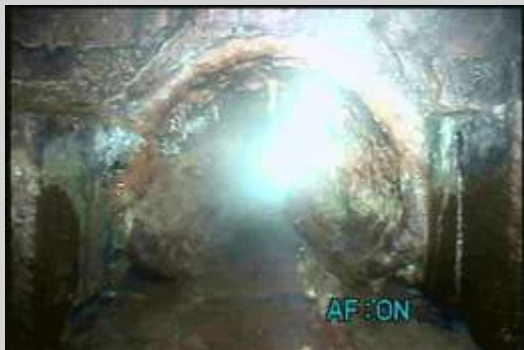
12 O'Clock Outflow

6 in. Circular Gravity Sewer
Pipe Out @ 12 O'Clock

Pipe Material: **Clay** ☐ Pipe Lined

Invert Depth: **3.66** (ft.) Flow Characteristics: **Slow**

Deposits: ☒ None ☐ Mud ☐ Sludge ☐ Debris ☐ Grease

Infiltration: **None**

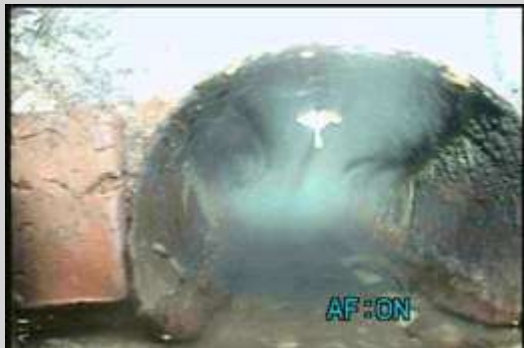
6 O'Clock Inflow

4 in. Circular Gravity Sewer
Pipe In @ 6 O'Clock

Pipe Material: **Clay** ☐ Pipe Lined

Invert Depth: **3.50** (ft.) Flow Characteristics: **Slow**

Deposits: ☒ None ☐ Mud ☐ Sludge ☐ Debris ☐ Grease

Infiltration: **None**
